Manhole Inspection Summary

Manhole # S21MM_011MH

Insp Date: **7/3/07 9:57 AM**

Location Address: **2233 FULTON AVE**

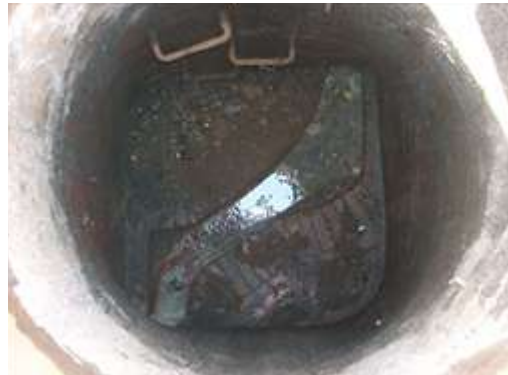
Top View

Comments **"S" shaped channel**

S SHAPE CHANNEL

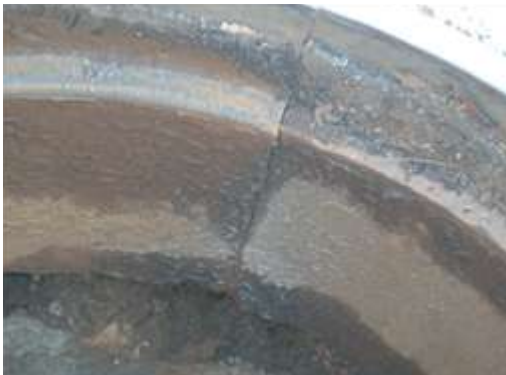
Defect 3

Frame Offset: **0** (in.) Condition: ☐ Sound ☒ **Cracked** ☐ Leaks

CRACKED FRAME

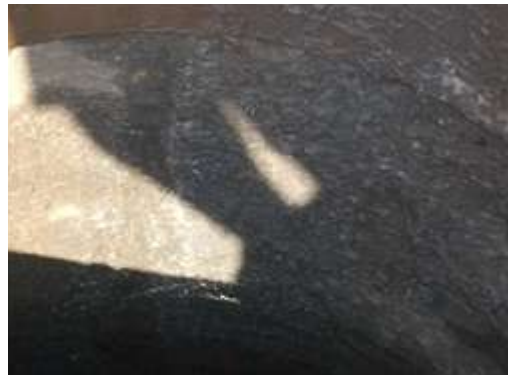
Defect 2

Infiltration: ☐ None ☐ Joint ☐ Cracks ☐ Mortar ☐ Roots ☒ **Wall**

INFILTRATION OF CORBEL

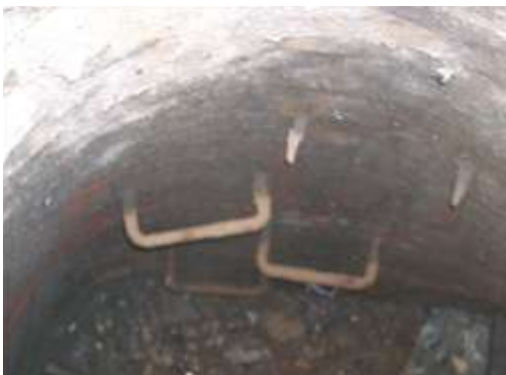
Defect 1

Steps Count: **3** Missing: **1** ☒ **Corroded**

MISSING AND CORRODED STEPS

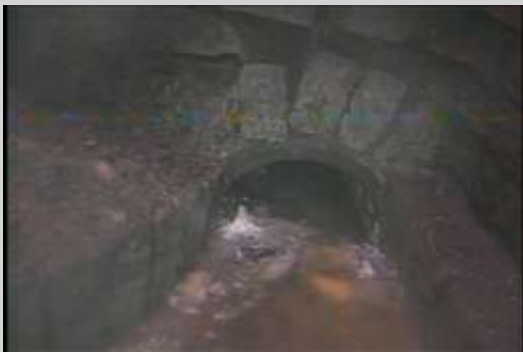
12 O'Clock Outflow

Pipe Height: **8.4** (in.) Rod and Bar (Angled)
Pipe Material: **Clay** ☐ Pipe Lined
Invert Depth: **9.49** (ft.) Flow Characteristics: **Slow**
Deposits: ☐ None ☐ Mud ☐ Sludge ☒ **Debris** ☐ Grease
Silt Depth: **4** (in.) Deposits Extent: **Medium**
Infiltration: **None** Pipe Seal Cond: **Sound**

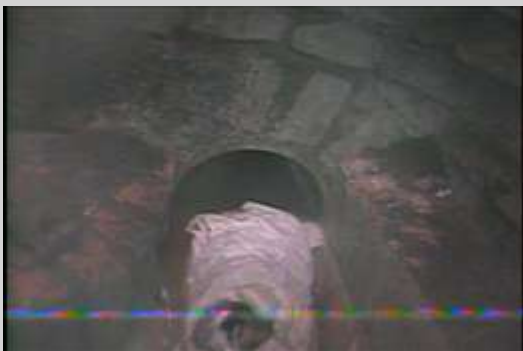
6 O'Clock Inflow

Pipe Height: **8.4** (in.) Rod and Bar (Angled)
Pipe Material: **Clay** ☐ Pipe Lined
Invert Depth: **9.43** (ft.) Flow Characteristics: **Slow**
Deposits: ☐ None ☐ Mud ☐ Sludge ☒ **Debris** ☐ Grease
Silt Depth: **6** (in.) Deposits Extent: **Heavy**
Infiltration: **None** Pipe Seal Cond: **Sound**
